NATIONAL ADVISORY COMMITTEE FOR AERONAUTICS

LABORATORY INVESTIGATION OF ICING IN THE CARBURETOR

AND SUPERCHARGER INLET ELBOW OF AN AIRCRAFT ENGINE

IV - EFFECT OF THROTTLE DESIGN AND METHOD OF

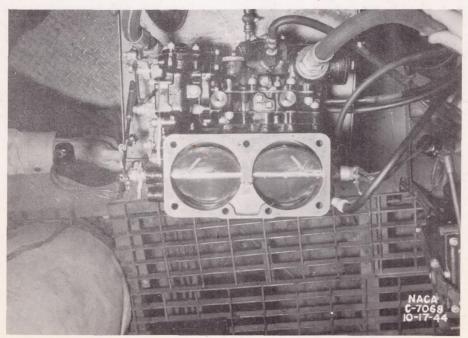
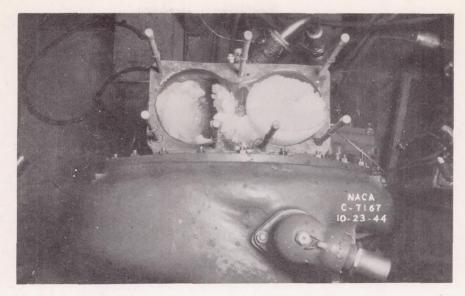
In two of the runs, small formations of ice on the tips of the throttle plates were noted. Such formations can be observed on the under side of the throttle plates in figure 5. Light frost was found on the upper side of the throttle plates at the center of the carburetor in two runs. For other than these formations, ice-free throttle plates were maintained during all runs.

The ice formation in the supercharger inlet elbow in figure 5 is typical of the type that developed with the heated plates. Ice also accumulated in the space between the bottom of the carburetor and the top of the supercharger-inlet-elbow rib and extended outward into the air stream. At the low throttle openings in several

(a) Ice formation in supercharger inlet elbow.

(b) Ice formation on throttle-plate edges.

Figure 5. - Serious icing with heated throttle plates. Carburetor-air temperature, 35° F; relative humidity, 100 percent; initial air flow, 4670 pounds per hour; fuel-air ratio, 0.080; minimum air flow after 15 minutes, 4535 pounds per hour; power input per plate, 500 watts.

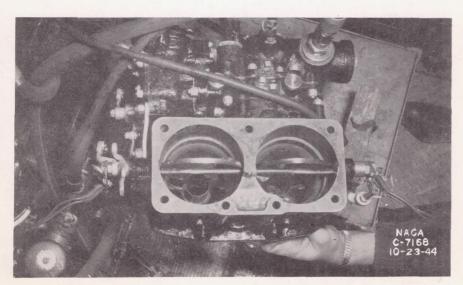
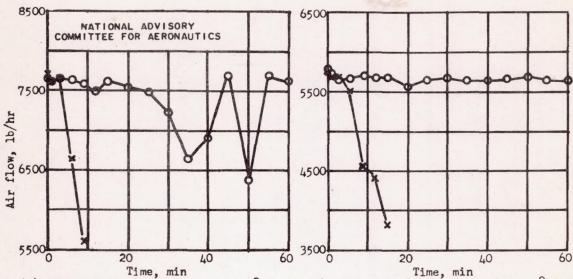
instances, the air flow was considerably reduced by ice accretions, which had built up in the front part of the carburetor throttle barrels, although the throttle plates remained free of ice. An ice formation that resulted when the left plate was unheated and the right plate heated is shown in figure 6. With the heated throttle plate maintaining an opening in the right throttle barrel, it was possible to ice the left throttle barrel until it was completely filled with ice. A small ice formation can be seen on the unheated throttle plate in figure 6.

(a) Supercharger inlet elbow with ice completely blocking left inlet; right inlet under heated throttle plate open to passage of air.

(b) Carburetor bottom view with ice adhering to tip of left unheated plate.

Figure 6. - Serious icing with left throttle plate unheated and right throttle plate heated. Carburetor-air temperature, 34° F; relative humidity, 100 percent; initial air flow, 4670 pounds per hour; fuel-air ratio, 0.080; minimum air flow after 3 minutes, 2000 pounds per hour; power input to right plate, 600 watts; power input to left plate, 0 watt; water injection, 600 grams per minute.
